CAAP Final Report

Prepared for: *U.S. DOT Pipeline and Hazardous Materials
Safety Administration*

Project Title: An Inorganic Composite Coating for Pipeline
Rehabilitation and Corrosion Protection

Prepared by: Hao Wang, PhD; Milad Salemi; Jiaqi Chen, PhD;
P.N. Balaguru, PhD; Jinhao Liang; Ning Xie, PhD

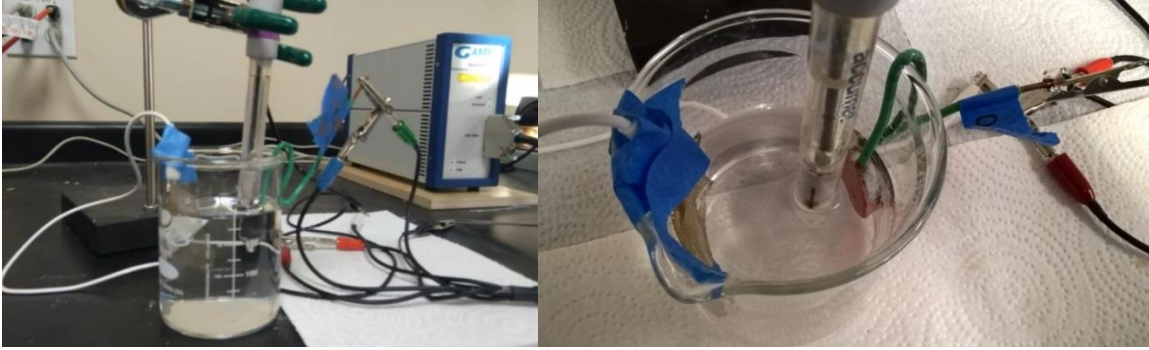
Figure 2 EIS testing with coated sample

EIS measurements were conducted using a three-electrode system, as shown in Figure 2. The coated steel coupon served as the working electrode, while the counter electrode and the reference electrode used were a platinum grid and a saturated calomel electrode (SCE), respectively. The corrosive environment was provided by 0.3% aqueous NaCl solutions. The EIS measurements were carried out using Gamry Reference 600 device, which is high-performance, research-grade potentiostat/galvanostat/ZRA designed for fast and low-current measurements. The steel was polarized at ± 10 mV around its open circuit potential (OCP) by an alternating current (AC) signal with its frequency ranging from 300 kHz to 5 mHz (10 points per decade).

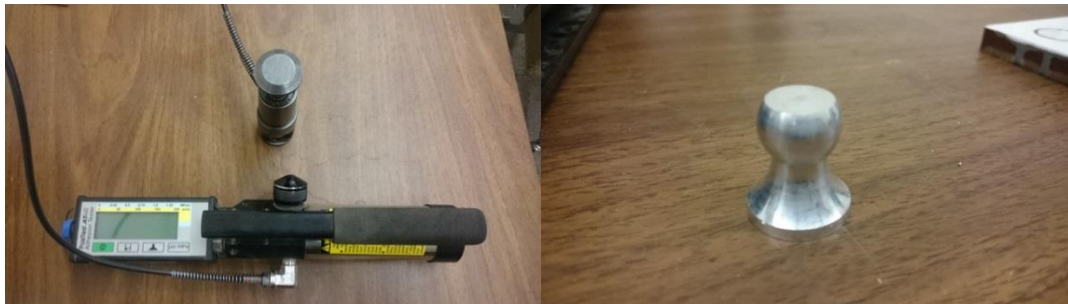
Figure 7 Manual adhesion tester and dolly

The steel coupons that were used in the accelerated corrosion test were chosen to have the dimension of 12×4×0.5 inches. The coating thickness was measured using PosiTest DFT coating thickness gauge. The adhesion strength of coating was evaluated according to ASTM-D7234. The PosiTest AT-M Manual Adhesion Tester by Deflesko was used to perform adhesion strength test, as shown in Figure 7.

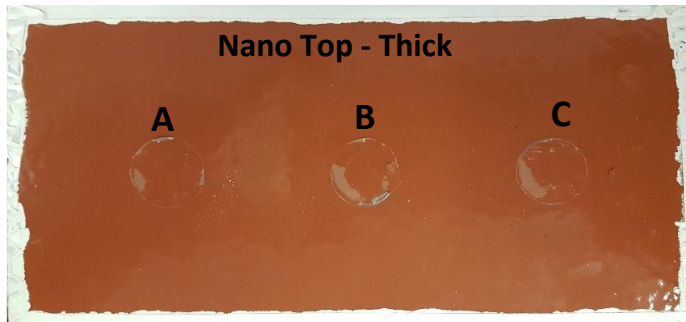
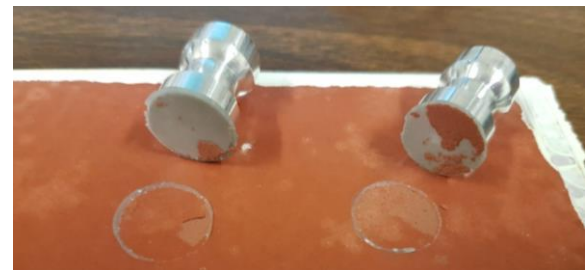
Figure 9 Interface Failure Patterns of Different Coating Systems: (a) 3M sol-gel on top; (b) nano-film on top (thin); and (c) nano-film on top (thick)

The summary of pull-off strength results before and after 30-day and 60-day corrosion cycles is shown in Table 2. It was found that the pull-off strength increased after 30-day corrosion cycle, which was probably due to the continuous curing effect of coating. Figure 9 shows the interface failure patterns after pull-off test. It was found that the sample with 3M sol-gel performed well after 30-day cycles, but appeared with powdered surface after 60-day cycles. The geopolymer coatings with nanofilm performed well after 60-day cycles, although the pull-off strength decreased for one inorganic coating system. This also indicates that no corrosion happened to reduce the pull-off strength. The failure patterns at the interface indicated that no corrosion happened at the interface between coating and steel plate.

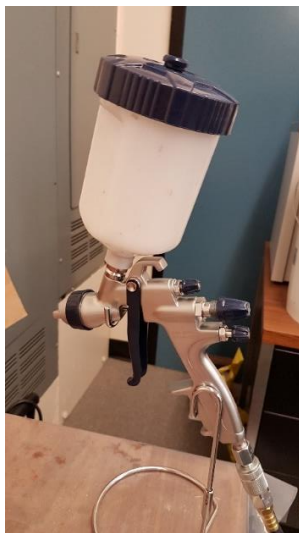
Figure 13 HVLP spray gun for coating spray

To achieve uniformly coated surface, steel plates were coated using 1.4-mm nozzle tip high volume low pressure (HVLP) spray gun, as shown in Figure 13. The original water content in the coating mixture proved to be incompatible with this spray gun and coating could not be properly sprayed or sprayed at all. This was contributed by relatively higher viscosity and lower surface tension of the coating, which makes flow of coating difficult. Although the larger nozzle spray gun was able to spray original coating mixture, the results were found far from satisfactory. Because of the thick mixture, coating would be spattered in droplets on the surface and could not achieve smooth finish. Frequent clogging of gun nozzle also happened. To solve this problem, the water content was increased from 6.25% to 9.1% of coating mixture, which enables the HVLP spray gun to spray coating mixture.

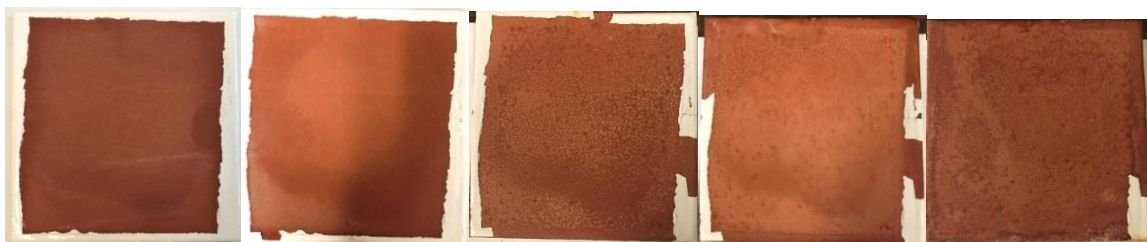
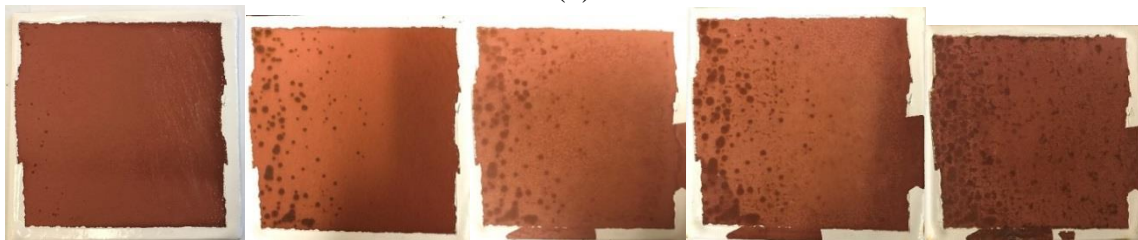
Figure 15 Appearances of coating samples with (a) 1%; (b) 3%; and (c) 5% titanium oxide after 30-day corrosion cycles

The appearances of coating samples after 30-day corrosion cycles are shown in the Figure 15-17, respectively, for the coatings added with titanium oxide, silica, and graphene oxide. In these figures, the pictures from left to right were observed with the increase of testing time and the changes of coating appearance were observed.

Table 4 lists the coating thickness for different samples. Relating the coating thickness with the observed coating appearance after accelerated corrosion testing, it was noted that thin coating layer had relatively more black dots after corrosion test, and as for all samples, because of the uneven thickness, the black dots were usually generated from thin area, e.g. Ti-3%, Ti-5%, Graphene-1%, etc. samples.

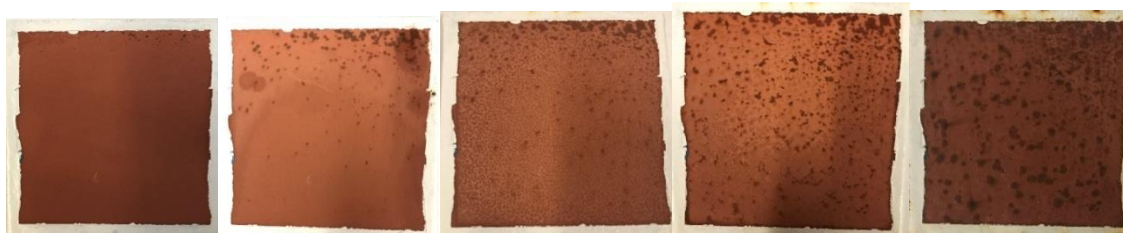
Figure 16 Appearances of coating samples with (a) 1%; (b) 3%; and (c) 5% silica after 30-day corrosion cycles

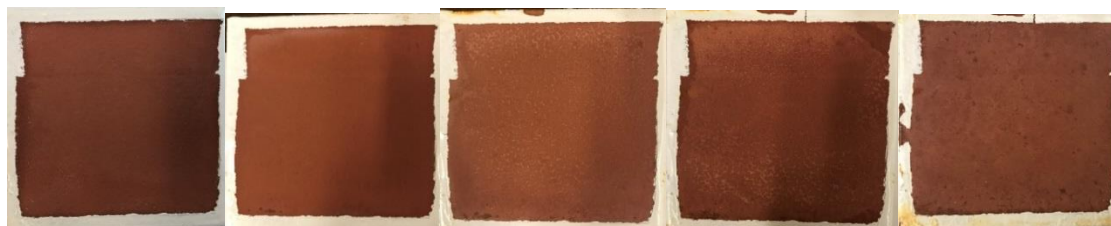
Figure 17 Appearances of coating samples with (a) 1%; (b) 3%; and (c) 5% graphene oxide after 30-day corrosion cycles

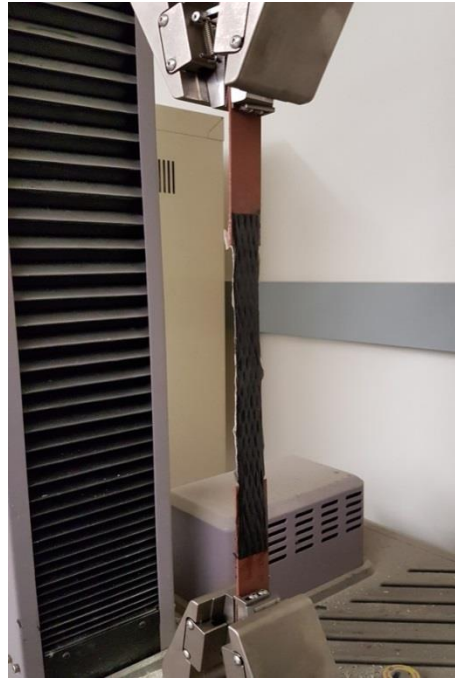
Figure 18 Illustration of (a) test setup and (b) picture for lap shear test

The test setup is based on the one recommended by ASTM D1002-10, which was modified to include CFRP laminate as the mediator part overlapped with two steel sheets. The overlap length (bond length) on one metal sheet was held to be constant (a); while the bond length (b) changed on the other steel sheet. This was used to investigate bond failure behavior with change of bond length on the coated and uncoated steel sheet samples. A displacement control tensile loading with the rate of 1.27mm/min was applied to the specimen till failure occurs, which was adopted from ASTM D1002. Figure 2 shows the test setup and the picture of lap shear test.

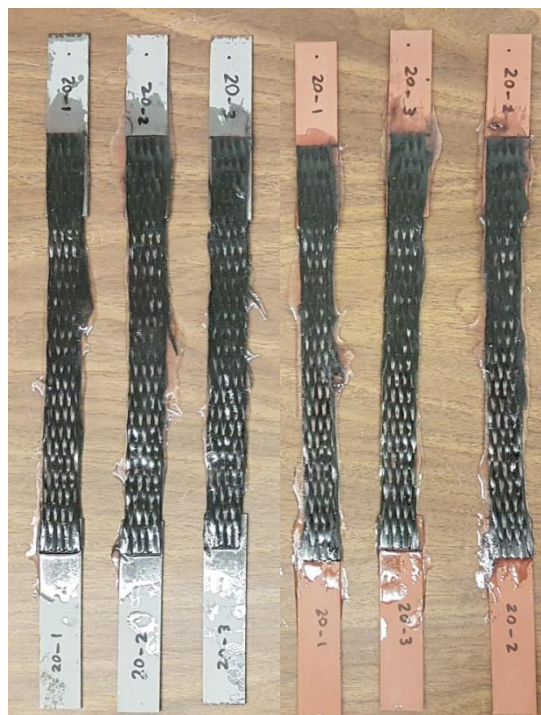
Figure 20 Lap-Shear specimens prepared: uncoated (left) and coated (right).

Three specimens were prepared for uncoated and coated steel sheets with CFRP laminates, respectively, as shown in Figure 20. The bonding length between CFRP and steel was 20 mm at both ends. Each of the steel sheets at two ends of the specimens was sand blasted prior to fabrication of specimen. The reason that 20-mm bond length was chosen as comparison basis was that the peeling stresses at edge of CFRP were less severe and the stress distribution along the bond is more uniform for the shorter bond length. In addition, it was found in finite element analysis that steel sheets would go into yielding phase if the bond lengths are longer than 20mm. Coatings on the steel sheets were performed using spray gun. The lap-shear tests were conducted using MTS machine with displacement control at displacement rate of 12.7 mm/min.

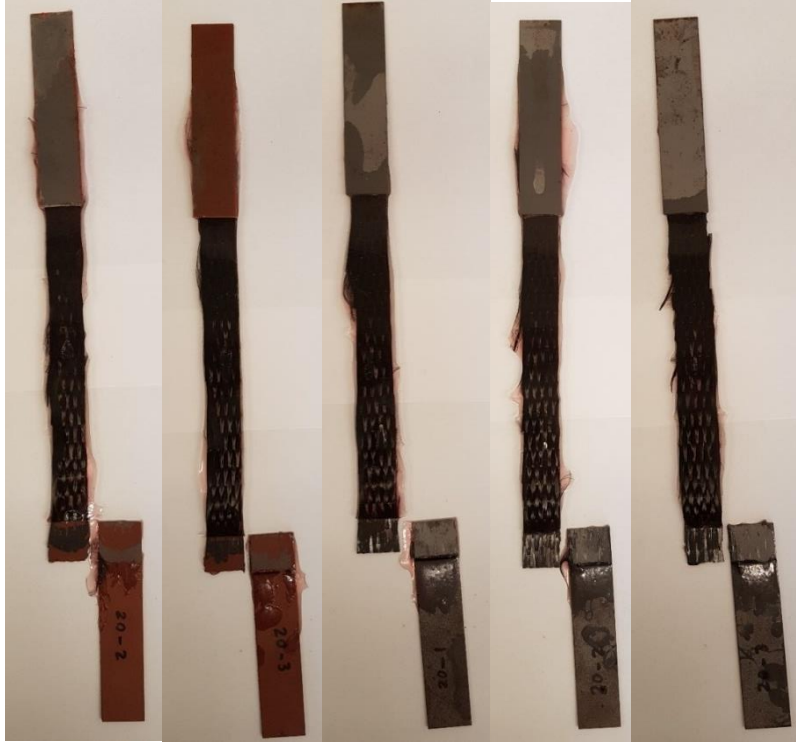
The appearances of specimens after failure are shown in Figure 21. The failure patterns were consistent showing the interface debonding between steel plate and coating.

Figure 21 Specimens after failure (from left to right): Coated-20-2, Coated-20-3, Uncoated-20-1, Uncoated-20-2, Uncoated-20-3.

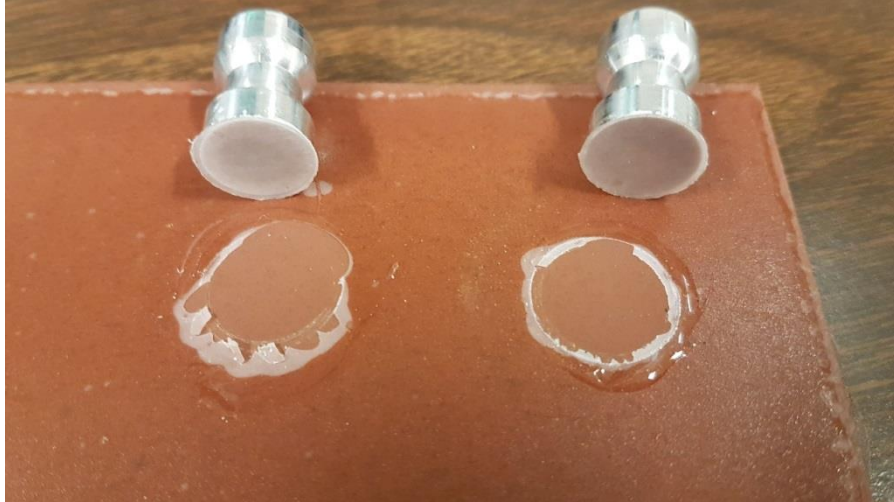
Two specimens were coated with inorganic coating using spray gun and cured in the oven at 80°C (175°F) for 72 hours. DowAksaCarbonBond300H saturant resin used in CFRP was applied on top of the cured coating samples. Thickness measurements were repeated on top of the coating and the average thicknesses were 144 and 152µm on two specimens, respectively. Pull-off test was conducted on coated specimens to measure the bonding strength between saturant resin and inorganic coating. Table 7 lists the measurement data of pull-off strength and the average value was found being around 5MPa. Figure 22 shows the post-failure appearances of specimens after pull-off test. It can be seen clearly that the failure occurs at the interface between resin and coating.

Figure 22 Pull off strength performed on coated steel specimen topped with DowAksa CarbonBond 300H Saturant Resin

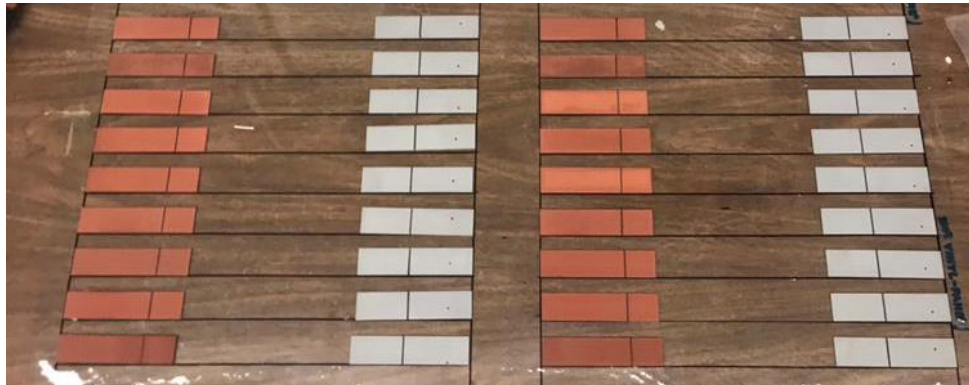
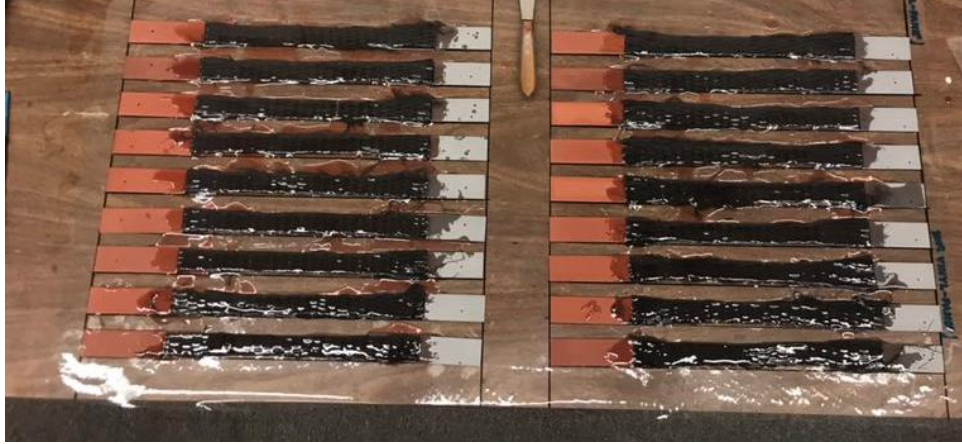
Various nano-modified coatings were tested with CFRP for shear bonding strength. The bond length on the coated steel sheet end was selected to be 30mm. The bond length at the opposite end on uncoated steel sheet was selected to be 50mm. DowAksa Carbon300H resin was used to impregnate the carbon fabric pieces for specimen fabrication. The specimens were cured for 10 days in room temperature after they were in the oven at 60°C for 48 hours. Figure 23 shows the samples prepared for lap shear test. A total of 22 specimens were tested. The lap shear tests were conducted using an MTS machine with 12.7mm/min displacement control loading.

Figure 23 Samples prepared for lap shear test
